By Robert Lundgren with Anthony Tully Edited by Tony DiGiulian

On November 13, 1942, the Japanese battleship *Kirishima* was sunk in the first US-Japan battleship duel of World War II. Her wreck laid undisturbed until discovered by Dr. Bob Ballard in 1992 as part of a joint expedition by the U.S. Navy and The National Geographic Society to locate and document the shipwrecks in Iron Bottom Sound of the ships lost during the battles for Guadalcanal. Dr. Ballard's exploration of *Kirishima*'s wreck was cut short by a near-fatal mishap which made it necessary for Dr. Ballard to make an emergency ascent. As a result, only nine minutes of video was taken of the *Kirishima*'s wreck with very little of the port side viewed and only a small portion of the aft starboard side. Charles Haberlien, a naval historian with the U.S. Naval Historical Society, was with the 1992 expedition and used the expedition's ROV to film some of the debris field in 1992, but this was very limited and incomplete. This and other data gathered during this exploration was used as part of my 2009 essay "<u>Kirishima</u> Damage <u>Analysis</u>."

A second expedition, mounted by Paul G. Allen's company <u>Vulcan Inc.<

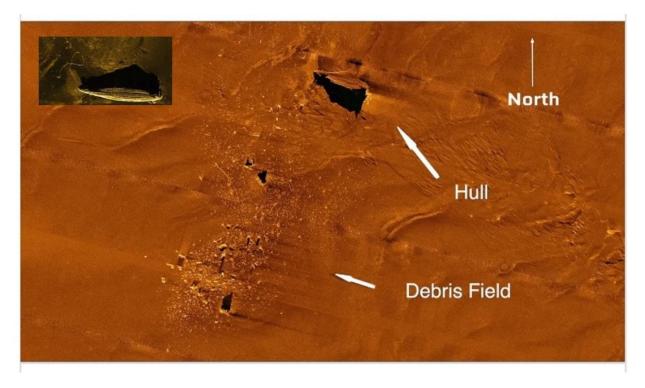
Figure 1 - Sonar image of *Kirishima* wreck site and debris field

Figure 1 shows that the stern of the wreck is pointing west at approximately 285 degrees and the hull break points east at approximately 105 degrees. When I first saw the sonar image, I was surprised. The debris field was not where I expected it. I had assumed the debris field was largely concentrated where the bow break was. This clearly shows it is not and that the debris originates at the point of her stern and drifts south roughly at 195 degrees for what appears to be approximately 3-4 ship lengths. The sonar also shows that *Kirishima* did not break evenly. Her port side is longer than her starboard side. Anthony Tully believes that the large objects producing shadows in the debris field may be part of her pagoda superstructure and her bow. Unfortunately, the 2019 expedition schedule did not permit the ROV to film this area and positive identification of these structures will require a future visit.

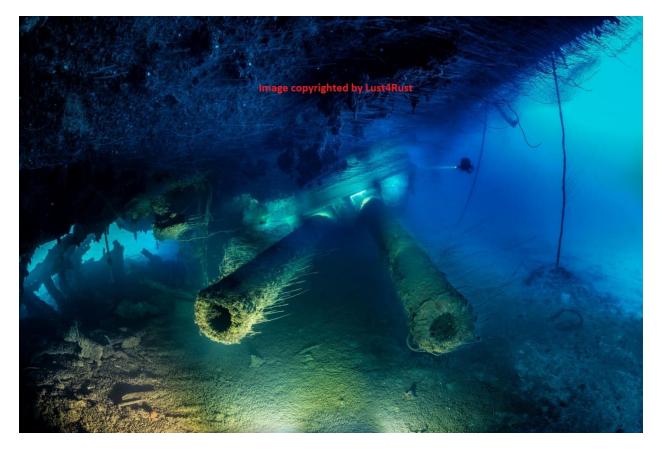
Figure 3 – Turret 'A' on the inverted wreck of *Nagato* Photograph copyrighted 2015 by Pete Mesley of <u>Lust4Rust</u> and used here by his kind permission

As can be seen in Figure 3, the Japanese battleship *Nagato* capsized after sinking at Bikini and her turrets are still in their barbettes. Turrets 'A' and 'D' remain suspended above the seabed as the wreck rests on the roofs of turrets 'B' and 'C' and divers can swim under the other turrets. These turrets have had 70 plus years to fall out, yet they are still snug in their barbettes. In addition, the twelve turrets on the battleships *Fuso* and *Yamashiro* have not been located on the sea floor although both battleships have capsized. The simplest explanation is that all twelve turrets are still in their barbettes and are buried under their wrecks. The aft turrets for *Hiei* and the aft turrets for *Kirishima* have also not been discovered in their debris fields, with again the simplest explanation being that they remain in their barbettes and are now buried in the sea bottom. So, I now feel I made an error in my 2009 articles to say that they had fallen out.

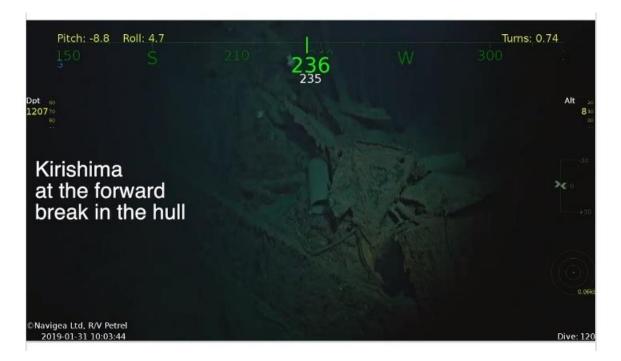
Figure 4 shows *Kirishima* at her forward hull break with secondary powder casings which are still on the wreck. This tells us that we are at her secondary shell powder magazine. There are thousands more in the debris field along with main powder casings. This was well documented by Charles Haberlien in 1992 and I have seen this film and can vouch for this description. Many of the powder casings are crushed, torn and flattened, some with one end popped open, others intact. No projectiles have been discovered by either the 1992 or 2019 expeditions. More importantly, I believe in *Kirishima*'s case that what we are seeing is the total consumption of all or nearly all projectiles. *Kirishima*'s bow is not just separated, it has been obliterated. Propellant powder cannot burn underwater and it has not been consumed, as much of it is still present in the debris field. Therefore, the powder was not the source of the explosion.

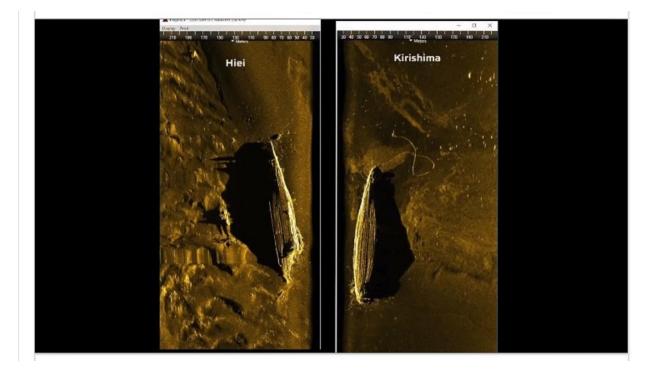
Figure 5 – Comparison of *Hiei* and *Kirishima* wrecks

On the *Petrel*'s Facebook page there is a comparison photo of the *Hiei* and *Kirishima* wrecks, shown here as Figure 5. The anchor chain which drapes across *Kirishima*'s stern is

clearly visible in the sonar image. A comparison of the two wrecks is potentially useful. The wreck of *Kirishima* is more intact. *Hiei* ripped apart at approximately frame 156 on her starboard side, which is where her aft mast is located and just forward of her aft stack, and then she ripped diagonally to approximately frame 132 or where her forward stack was located. The stern section of her wreck is slightly shorter than *Kirishima*'s and is now approximately 361.82 feet long. Both the port and starboard aft 5-inch 40 caliber guns were discovered in her debris field along with a large section of her aft mast that housed a 25 mm gun mount and its ready ammunition resting on her hull. What is striking about her sonar image is the lack of debris around her stern. There is a debris field 500 meters from her stern but not enough to make up for the missing bow section. Photos of her hull break show her plates are all bent down in one direction.

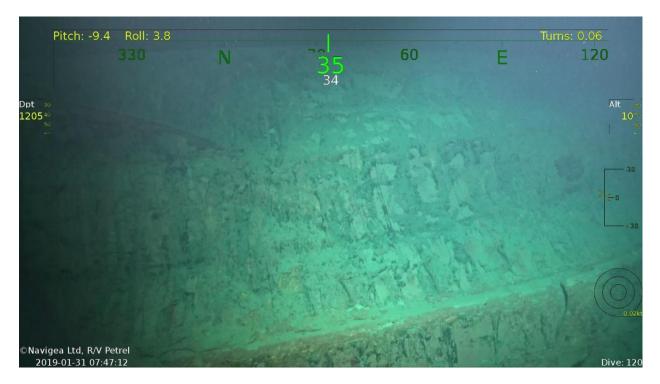
Figure 6 - 16-inch shell hit Frame 76 port side

The sequence of screencaps from the *Petrel*'s ROV revealed a dramatic picture. As the *Petrel*'s ROV approached *Kirishima* on January 31, 2019, her massive hull suddenly appeared from the abyss. They had approached on her port side very close to where the bow was broken. Subsequently the ROV would make a complete circuit of the wreck, passing down aft, behind the stern, and back up starboard side to the forward break. As a result, documentation of the main wreck was close, if not quite, complete. The edge of the bilge keel in Figure 6 above marks the location at about frame 80. Immediately one of Lt. Ikeda's underwater shell hits appear just forward of the bilge keel at approximately frame 76. This was a surprise because I thought all hits were on the starboard side. The only time that *Kirishima* presented her port side to U.S.S. *Washington* was at 0107 when *Washington* fired her last salvo. *Washington*'s logs do not list the exact time of this salvo, meaning that the time could have been 0107.00 or 0107.59, but *Kirishima* was observed circling to port by 0107. This helps with the timing of any port side hits discovered.

This hit is directly into her main powder magazines. Lt. Ikeda also placed two hits through the barbette structure of Turret 'B'. The exact timing of these two hits is unknown. He also placed two hits through Turret 'A' barbette, and we have dramatic testimony from *Kirishima*'s flooding control officer flooding the number one powder magazines. Both forward turrets were listed in *Kirishima*'s action report as being smashed. Now the wreck can no longer confirm the barbette hits as the forward barbettes no longer exist. I firmly believe based on all the primary documentation and witness accounts that the four barbette hits all took place. A

hit directly into her 'B' turret powder magazine might lead one to suspect a H.M.S. *Hood* type magazine explosion event to soon follow. This did not happen. There are several possibilities. The first and most likely is that when this hit was scored Turret 'B' had already been destroyed and her magazine had been flooded as a precaution. The second possibility is that while the damage shows an entry hole, we do not know if the projectile detonated. Like the projectile from U.S.S. *Massachusetts* that found the secondary magazine of the French battleship *Jean Bart*, the projectile may have been a dud. A third possibility is a U.S.S. *Boise* type incident in that the projectile worked as expected but the water coming through the hole flooded the magazine and prevented a major deflagration.

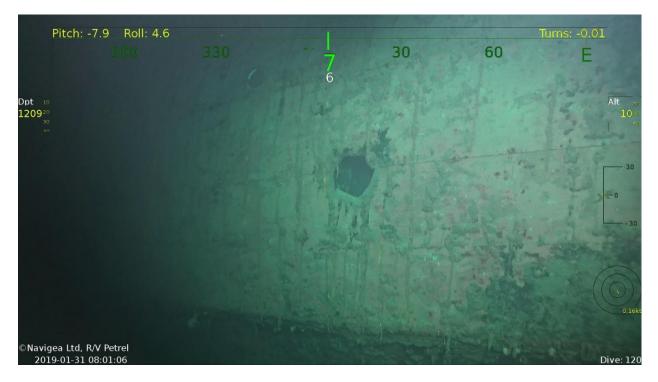
Figure 7 – 16-inch shell hit Frame 100 port side

The *Petrel*'s ROV now moves along the port side moving aft and quickly discovers another below-the-waterline hit at approximately frame 100 in Figure 7. This impact in my 2009 article I had on the starboard side destroying her forward starboard hydraulic pump room. However, the hit actually occurred on the port side and destroyed the port side hydraulic pump room. The ledge is the top edge of the torpedo bulge and marks the top edge of the main armor belt. This impact would also have taken place with *Washington*'s last salvo at 0107 and occurred simultaneously with the hit at frame 76. This is important because *Kirishima* lost the use of turrets 'C' and 'D' due to a loss of hydraulic pressure. Initially, when the H.M.S. *Invincible* class was built, British battlecruisers were fitted with only two hydraulic pump rooms to operate four main battery turrets. It was discovered that these two pump rooms could not operate all the turret functions simultaneously, so subsequent British battlecruiser and

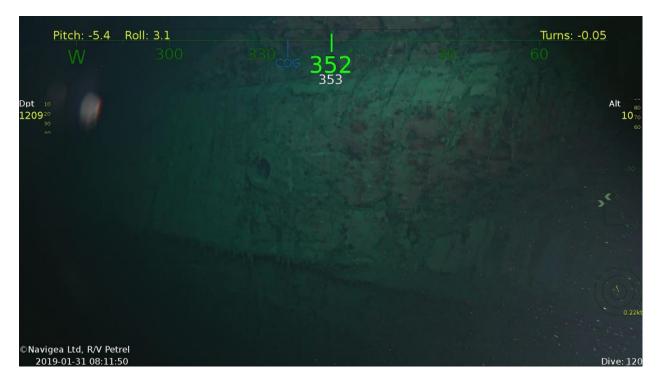
Figure 8 - Drainage pipe installed in 1937

The *Petrel*'s ROV now moves along the port side moving aft and another weird hole appears in Figure 8, but this is not battle damage; it is in fact part of her design. Its location is just aft of Turret 'C' and the bilge keel ends at frame 234 which crucially helps us locate where we are on the hull. This pipe is some form of drainage. It was installed in 1937. The pipe's exact purpose is not known. It appears to be related to draining the bilge; perhaps for cleansing purposes. There are two undocumented 5-inch shell hits just aft of this pipe in the 9 mm plate that made up her outer torpedo bulge.

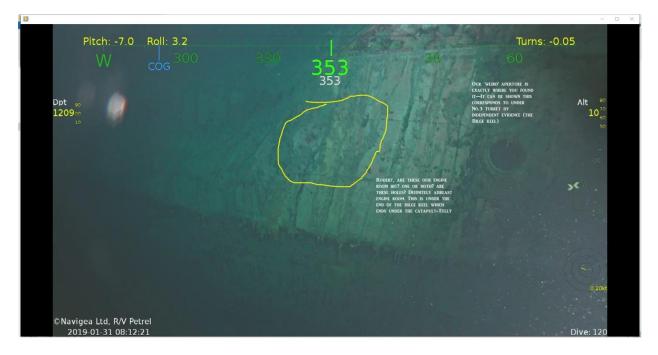
Anthony Tully first spotted two hits just aft of the pipe in the side shell as shown in Figure 10. The shells detonated on impact indicating a nose fuze projectile. Lt. Ikeda had listed a hit outside the engine rooms and I believed this was on the starboard side in my 2009 article. The hit listed was of major caliber and clearly these are not 16-inch shell hits but represent two unknown 5-inch shell hits again probably being scored around the 0107 time frame. As the ROV moved aft we approach the port side outer shaft at frame 258.

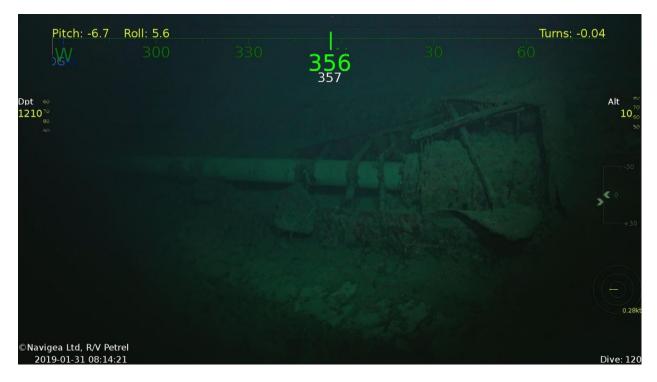
I believe that Figure 11 is the one of several under-keel detonations that struck *Kirishima* aft. This damage I believe also plays a critical role in why *Kirishima* will circle to port despite her rudders being jammed to starboard. At 0106 *Kirishima* is attempting to withdraw and has turned away so her stern is directly pointing at *Washington*. I believe this damage was scored around 0106 with *Washington*'s second to last salvo. MutItiple shells land near her stern and this one detonates under her keel blasting the plates that covered her shaft as it enters the hull peeling them back.

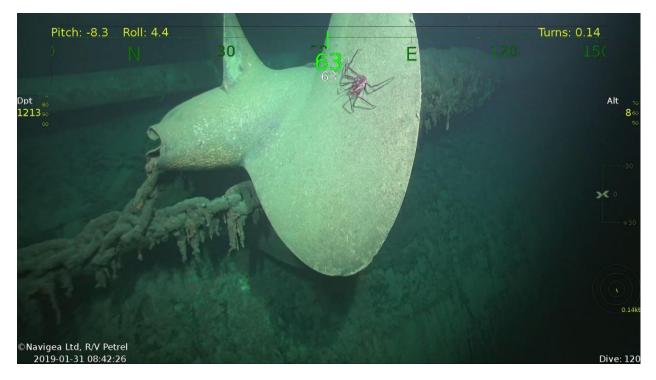
Figure 12 - Outboard port propeller remains in excellent condition

The condition of the outboard port propeller in Figure 12 is pristine, as a crab makes *Kirishima* his new home. What is important is to compare this to the condition of her starboard propellers. This is what an undamaged propeller blade should look like. The propeller tip has imploded slightly. To give the reader a sense of scale, the propeller diameters on *Kirishima* are 3.658 mm (12.00 ft) for the outer pair and 3.734 m (12.25 ft) for the inner pair.

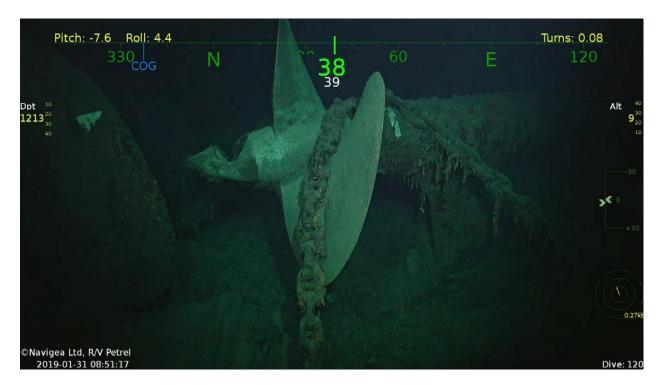
Figure 13 - Inboard port propeller is also undamaged

Figure 13 shows the inboard port propeller which was the last one known to be operational before she sank. The heavily jammed port rudder is now coming into view on the left side of this photograph. The propeller tip has imploded due to water pressure but the propeller itself is largely undamaged. The anchor chain when she broke apart now drapes over this entire area. There is a fragment hole in her hull at the bottom edge of the photo just a bit to the left of the anchor chain.

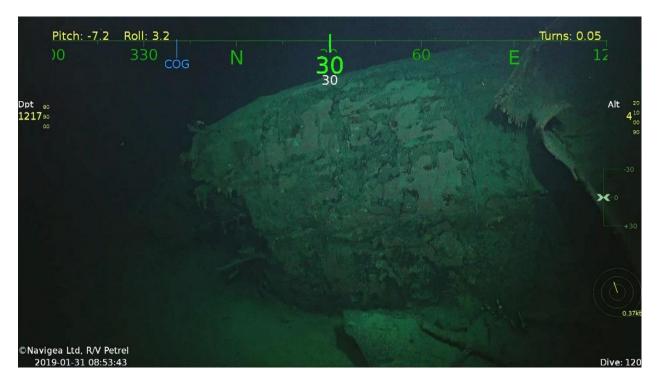
Figure 15 - *Kirishima*'s stern with bent keel

What remains of *Kirishima*'s stern was a surprise because it somewhat contradicts the image planted in my mind from a painting of the upturned wreck in the Ballard book. In that painting, the fantail was depicted as cleanly broken off and suggested that most of the admiral's cabin was gone. As Figure 15 shows, this is not the case at all. In fact, her entire keel is still attached. The fantail is buckled, not severed. She is missing the side plates for the last two or three frames or 4-6 feet, but her admiral's cabin is still largely intact.

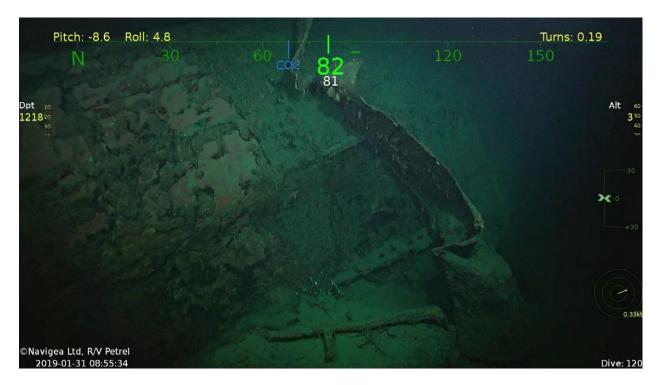
Figure 16 - Exit hole damage from two 16-inch shells seen on the port side aft of her rudder post

Lt. Ikeda placed three hits on the stern, and I have them a bit more forward in my 2009 article. They all hit aft of the rudder posts. I believe there are two hits one at frame 302 and 305 and both these shells detonated and are the two hits Lt. Cdr. Hank Seely observed from the *Washington* at 0105. I believe a third hit at frame 311 and simply went straight through the hull shattering the side plates at the very stern tip. The entry holes for these shells are not visible on the starboard side being now in the mud. The stern is not that wide and when the shells detonated, they sent their heavy nose pieces through the port side shell plating and peeled back her outer shell from within. The dark shadow at the mud line is a big hole which penetrates the other side of the plate right at the mud line. Fragment holes can be seen higher on the hull. When *Kirishima* sank stern first she landed on her stern tip and this bent her keel slightly but shattered the damaged side plates which removed the direct evidence of a 16-inch shell hit at the tip. I do believe it is a combination of shell damage and how she sank as to why the stern tip side plates are missing. I do believe it is incorrect to describe her stern as missing. The keel is still completely attached although it is bent due to her landing on it.

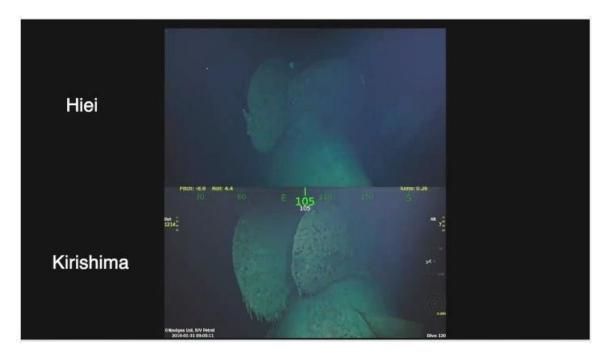
Figure 17 - Comparison view of Hiei's and Kirishima's rudder jams

Figure 17 is from the *Petrel*'s Facebook page and is a comparison of *Hiei*'s and *Kirishima*'s rudder jams. This photograph shows both *Hiei* and *Kirishima*'s rudder jams are almost identical. This damage in fact left *Hiei* crippled and making wide clockwise loops. While it makes perfect sense for a ship with her rudders jammed hard to starboard to circle to starboard, *Kirishima* did not. As the *Petrel*'s ROV moved to the starboard side an explanation became more evident.

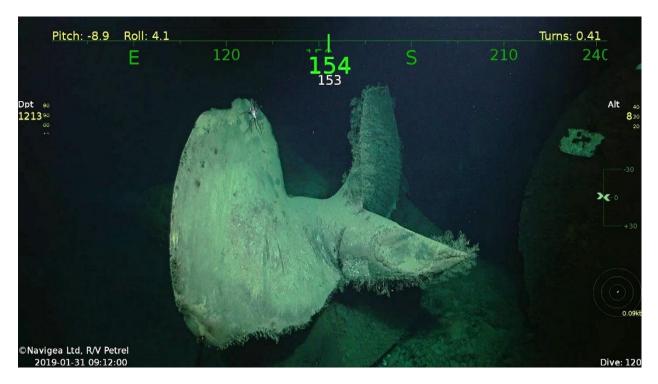
Figure 18 - Inboard starboard propeller

Figure 18 shows *Kirishima*'s inboard starboard propeller which is badly damaged and the bottom edge of one blade is broken. This propeller is also bent, chipped and dented.

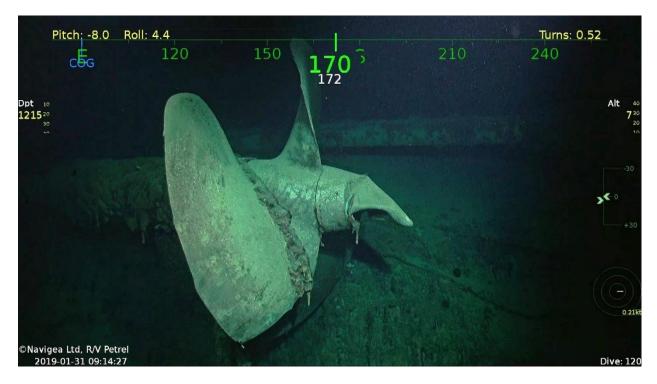
Figure 19 – Outboard starboard propeller

The *Kirishima*'s outboard starboard propeller and it too is badly bent and misshaped. It is quite dramatic to compare the port side propellers and the starboard side and just how badly damaged the starboard side propellers are.

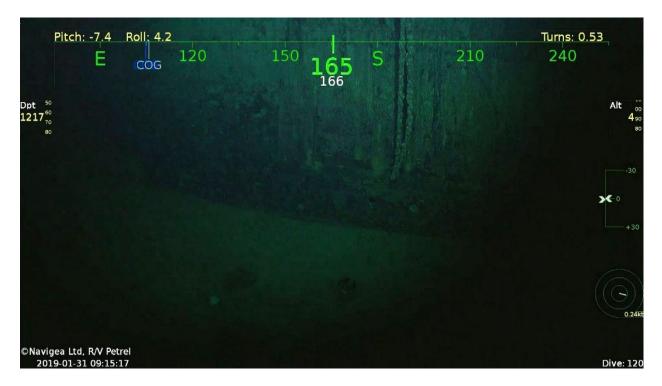
Figure 20 - Correction in 2009 article concerning hit behind chain and possible hit by USS Helena

In reviewing Figure 20, I need to correct an error in my 2009 article. In that article, I believed that I saw a hit behind the chain hanging off the outer shaft propeller blade. The 2019 film also produced a dark circle that at first glance looks like it might be a hit, but it turned out to be a shadow from the propeller blade itself. There is not a hit at this location. However, just to the left of the chain there is a shell impact between the 120-150 closer and below and to the left of the 150. Anthony Tully's eagle eyes spotted this impact and it appears to have been made by either a 5-inch AA common or this could be the hit she received on November 12 from the *Helena*. It is not a 16-inch shell hit and it is not part of the 17 x 5-inch projectiles listed by Lt. Ikeda for the night of November 15. I believe this is the hit she received on November 12 though I can't be 100 percent certain. It is either the hit from the *Helena* or an undocumented 5-inch shell hit from the *Washington*.

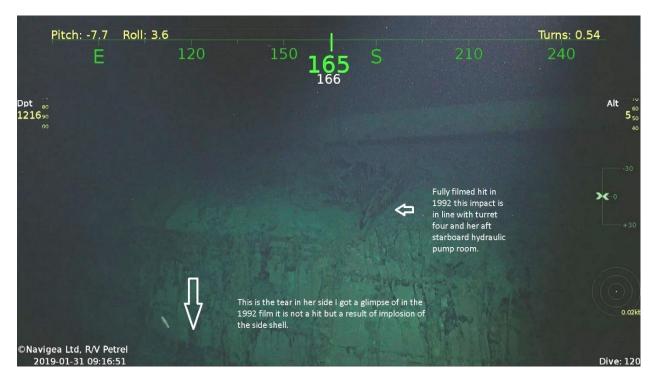
Figure 21 - Fully filmed 16-inch shell hit in 1992 and tear in her side shell due to implosion

The ROV moves forward and in Figure 21 captures the hit already noted in 1992 at frame 265 that is in line with Turret 'D' and the starboard aft hydraulic pump room. In the same picture is the tear in her side that seemed to be battle damage. Instead it now appears that this damage is a result of her torpedo bulge imploding.

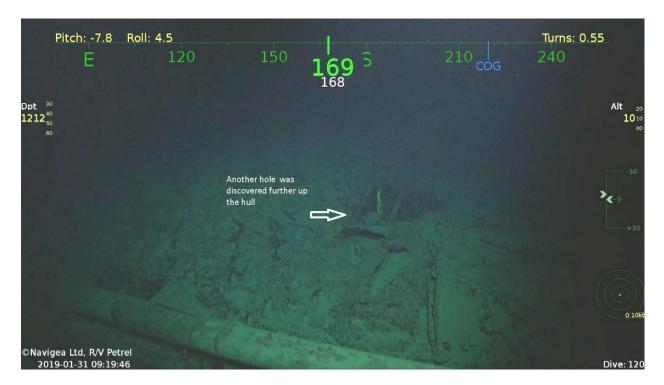
Figure 22 – Exit hole of 16-inch shell which then explodes under her keel, damaging both starboard propellers

I believe the shell impacted the aft starboard hydraulic pump room near the floor of that compartment which resulted in its immediate flooding. The impact would have begun fuze action within the projectile, but the shell exited the hull before the fuze activated due to the shape of *Kirishima*'s stern and then detonated under her keel. The resulting explosion warps both starboard propellers so that they are no longer stable and the crew was forced to shut down both starboard engines. This means that by 0106, when the next salvo jams her port rudder and disables her outer port shaft, she only has one remaining engine available, her inboard port engine that was now blocked by the port rudder turned almost sideways. The reason *Kirishima* circled to port was due to not applying any thrust on her starboard side and minimal thrust on her port despite her rudders being jammed to starboard. It was the propeller damage that had made turning the shafts unstable that forced her crew to shut them down and it does match the limited documentation that she only had a single operational engine before she sank. This is one of three projectiles that would have detonated under her keel at her stern. The shock damage would have been significant.

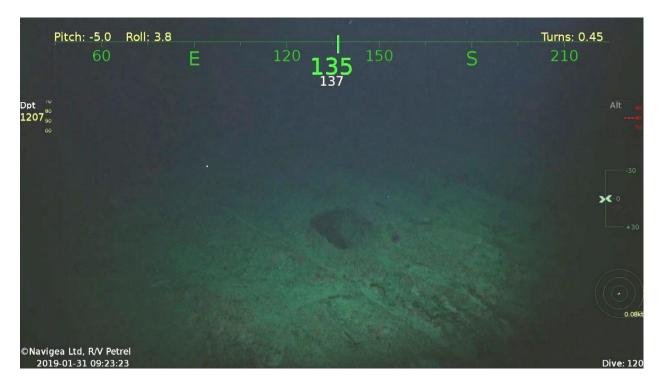
Figure 23 - A sea chest on Kirishima's keel

The ROV moves up onto her keel and in Figure 23 we find a sea chest and that her keel has suffered implosion damage roughly at the position of Turret 'C'. Unfortunately, by having the ROV move up onto the keel at this point, the 2019 survey misses the round object the hull is resting on that was seen in the 1992 survey. This object may be the bottom of Turret 'C' or it may instead be another part of her structure. The ROV moves back over her side and we see in Figure 24 and Figure 25 that her sides are badly deformed due to implosion as her TDS (Torpedo Defense System) has been crushed inboard.

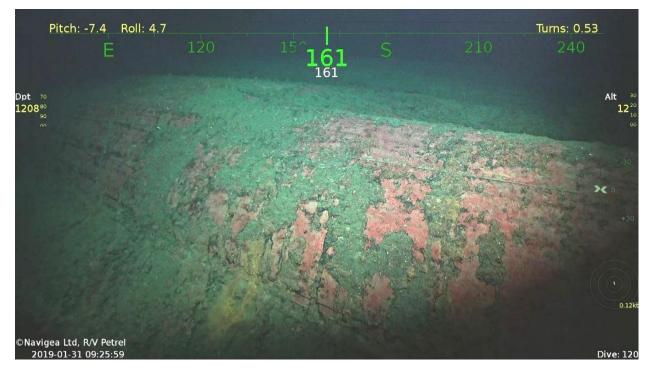
Figure 24 - Signs of implosion along Kirishima's keel

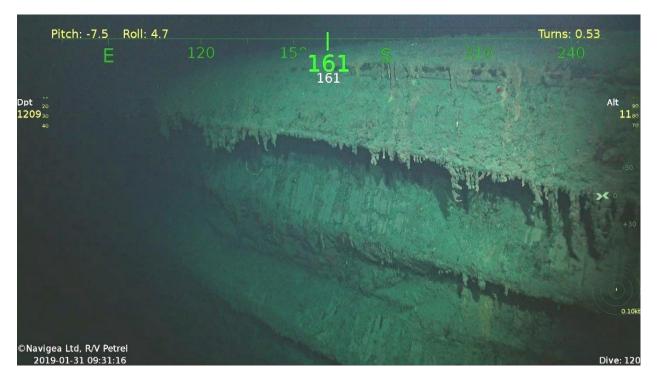
Figure 25 - Signs of implosion along her side shell on Kirishima's starboard side

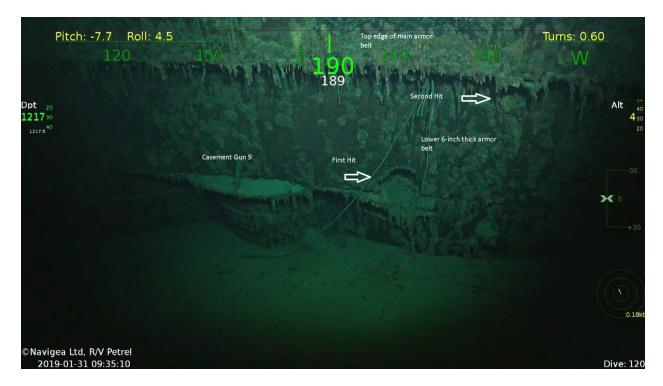
Figure 26 - Casement gun S9 showing two 16-inch shell hits through lower 6-inch VC plate

Then the first casement mounts are seen in Figure 26, which was a great surprise, because I thought they might be buried in the mud. The *Petrel*'s Facebook page shows casement gun S9 and one hit is easily seen but it is packed with mud. The second hit is harder to see as the top edge of the TDS hides it a bit and it too is now filled in with sediment. I wonder if both holes were filled by the damage control teams with a wooden plug before she sank. I have many photos of shell damage and the damage control teams sealed them with wooden plugs. Now the wood has rotten into sediment which is why they are plugged?

The plate these holes are in is 6-inches thick VC armor. The projectiles would have entered her main deck level just below the upper deck which housed the casement guns. These projectiles would have detonated close to amidships and threaten her aft secondary magazines. I believe these hits were scored on the *Washington*'s third salvo at 0102. Lt. Cdr. Hank Seely observed hits amidships from this salvo. Then Lt. (jg.) Kobayashi heard a report through voice pipes about fire in aft secondary battery casemates. The XO Commander Koro Ono ordered the aft magazines flooded and soon came a report via voice pipe confirming that this measure had been successfully executed.

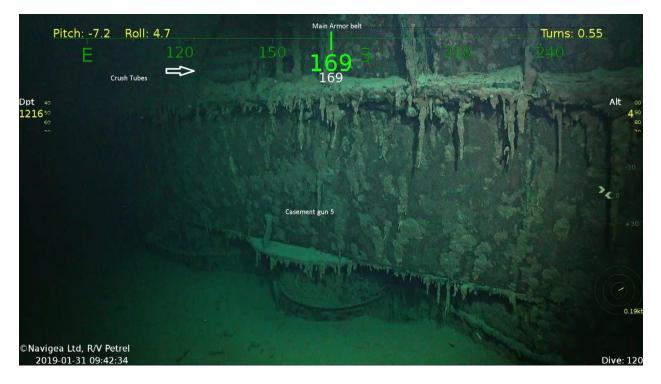
Figure 27 - Casement gun S5 showing blast damage to area outboard of main armor belt

Casement guns S5 and S7 are visible in Figure 27 and above them the torpedo defense system has been blasted apart exposing her main belt. The crush tubes are clearly visible, and the damage extends all the way down to her bilge keel. The barrel of casement gun S7 is

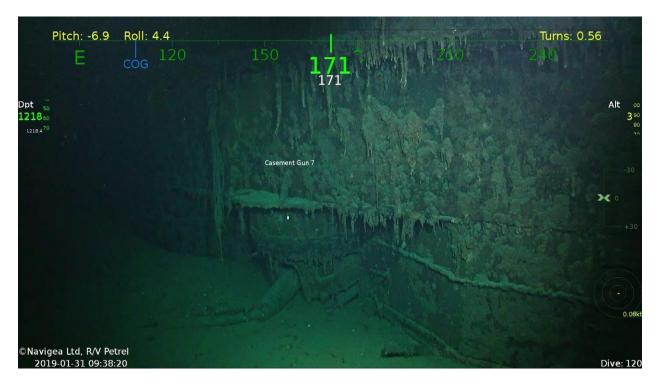
broken as can be seen in Figure 28; this occurred when *Kirishima* landed on the sea floor. There is no apparent hole in the main belt. The lower 3-inch belt has been pushed inboard, but this may be due to implosion of the inboard tanks that supported it and not directly due to battle damage. I have two possible explanations. The first is the least likely. There is no documentation on how effective the crush tubes would be at removing the AP caps from major caliber projectiles. They only covered the small area that remained above the waterline. While in theory it is possible a U.S. projectile could be de-capped by the crush tubes and then suffers nose shatter on the main belt which results in a pre-mature detonation of the projectile. I did not see any impact scar on the main belt. There is still a lot of support structure intact and if the main belt had suffered such an impact, I believe I would see this structure swept away.

Figure 28 – Casemate gun S7 with broken barrel

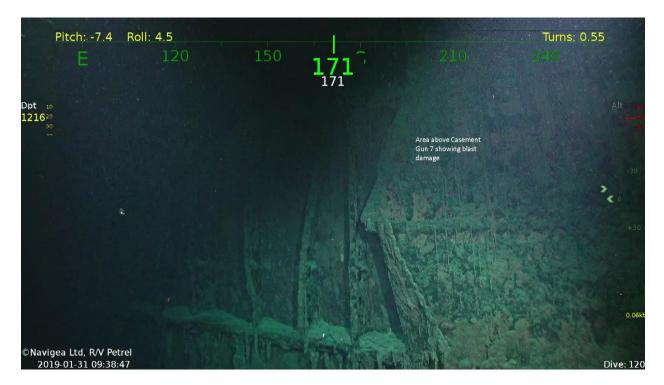
Figure 29 - Area above casement gun S7 showing extent of blast damage

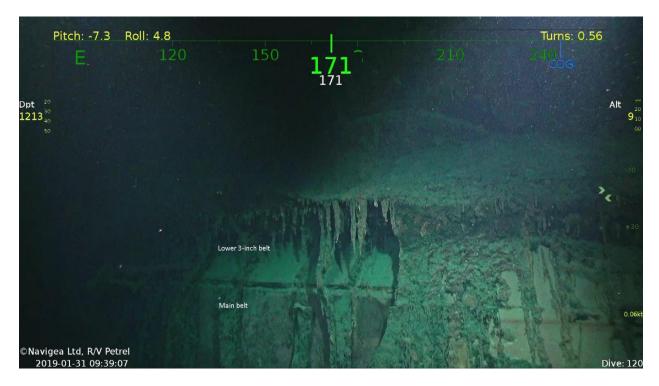
Figure 30 - Area above casement gun S7 and exposed main armor belt and lower 3-inch belt

A second possibility is the projectile impacted the water first which would begin fuze action and entered the torpedo bulge and detonated before it contacted the main belt and blasted a large section of the torpedo bulkhead and outer shell away. Though the damage looks impressive it is relatively minor in terms of reducing *Kirishima*'s combat capability. In this case her armor won. I believe this impact also occurred on *Washington*'s third salvo at 0101. Lt.(jg.) Kobayashi believed that *Kirishima* may have been hit by torpedoes and this damage may have given him that idea. From his perspective only a small area would have been visible looking over the side, but we know no torpedoes were fired at *Kirishima*. Lt. Cdr. Hank Seely saw from the *Washington*'s shells detonating at 0101 and I believe that this is one of those shells.

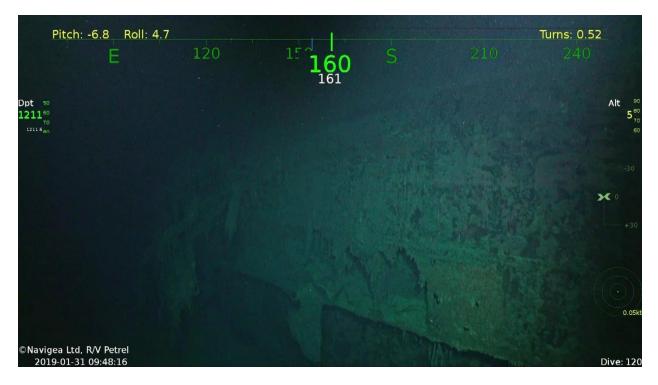
Figure 31 - Beginning of starboard hull break with hull shattered and peeled back from within

The ROV moves forward to the starboard hull break at about frame 94 in Figure 31. It is close to where casement gun 3 should be but I believe this gun is buried in the mud. I was hoping to find evidence for one more impact that Lt. Ikeda said was in this area. I believe the impact is buried in the mud and is not visible. In my 2009 article I estimated the projectile impacted the forward 5-inch gun mount that was in this approximate position. Unfortunately, all this area is buried and direct confirmation of a projectile hit in this area could not be confirmed.

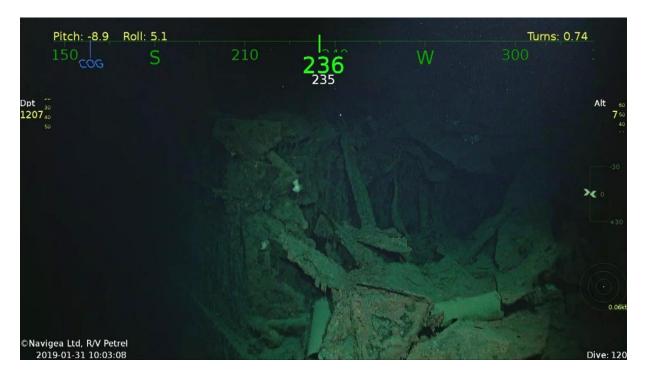
Figure 32 - Starboard hull break with secondary powder casings still on wreck

Figure 32 and Figure 33 show the massive internal damage at the starboard break with multiple powder casings still lying within the wreck. These tell us that we are at the secondary powder magazines. There are thousands more in the debris field along with main powder casings. When *Kirishima* capsized, she capsized to port. This would throw all the projectiles to the port side of the compartments that contained them. Then she sank stern first rising vertically as she plunged. This would pile up the projectiles on the aft walls of the compartment that contained them. It is actually difficult to get projectiles to detonate. Simply tossing them around typically does not provide sufficient force to initiate the fuze or crush the projectiles. They need a massive shock. Prior to her sinking all the forward powder magazines have been flooded and both barbettes have holes in them so the barbette structures are going

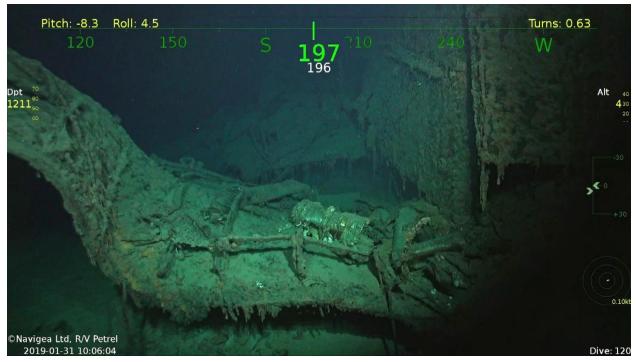
Figure 33 - Starboard hull break showing shattered hull

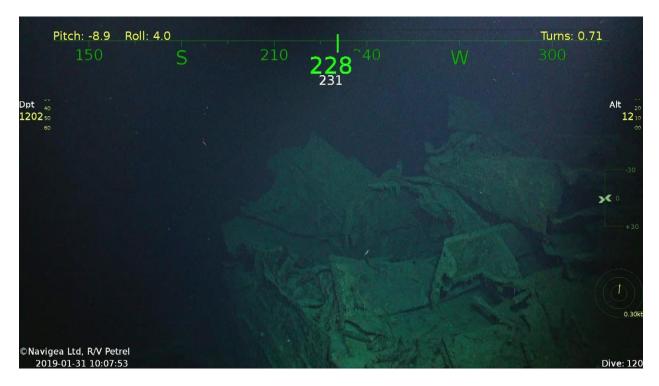
Figure 34 – Kirishima's hull has been peeled back from within

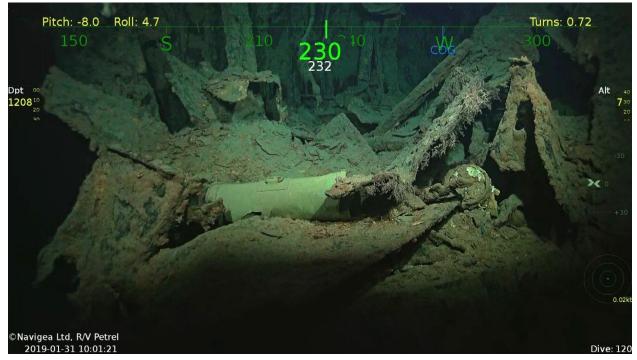
Figure 35 - Secondary powder casing

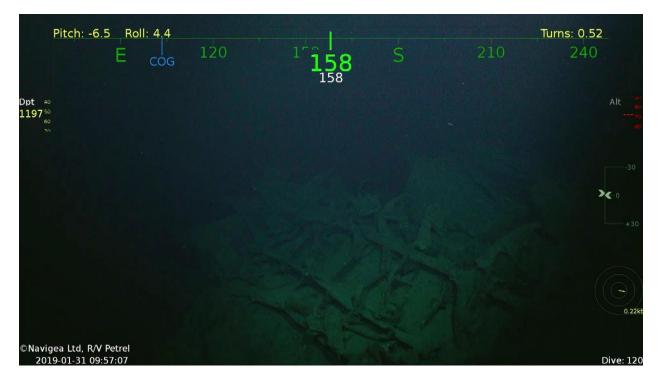
Figure 36 - Keel plates folded back over Kirishima's keel

Her bottom plates of her keel now peeled back over her keel from a massive internal force that ripped her apart. This is where the 2019 expedition ended.

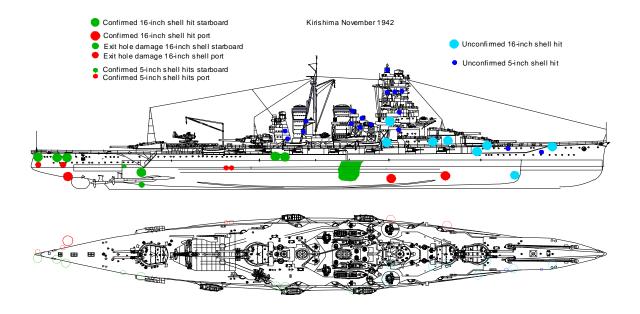
Below in Figure 37 is my "Hit Location" drawing from my 2009 article which has been updated to reflect the new information discussed in this article. Green is starboard side, red is port side, blue is unconfirmed. I believe that it is safe to say that *Kirishima* was struck between 17 and 21 times by 16-inch projectiles and between 17 and 20 times by 5-inch projectiles. We do not know for certain the caliber of projectile that struck the main gun range finder or that of the two projectiles that struck the bow, which are currently listed as part of the 5-inch total.

Figure 37 - Updated Kirishima hit locations based on 2019 expedition
