# By Robert Lundgren Edited by Tony DiGiulian

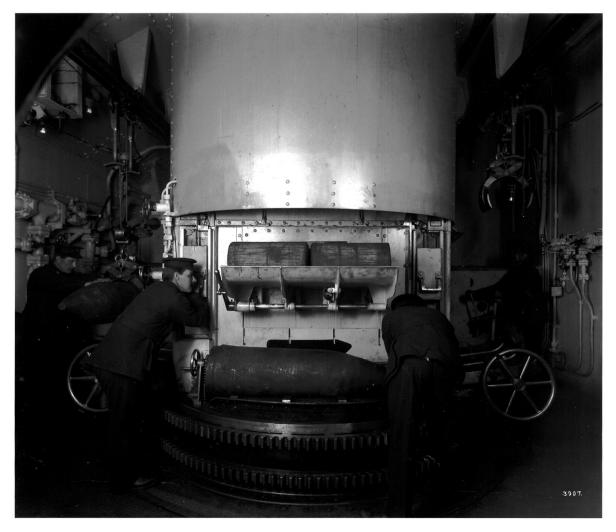
Shell and powder hoists on *Kongō*Photo courtesy of The Dock Museum, North Road, Barrow-In-Furness, Cumbria, U.K.

The above photo, taken of *Kirishima*'s sister *Kongō* when she was being built in Great Britain and before delievery to Japan, shows how the powder and shells were loaded onto the hoists. Projectiles were transported by a rail system to the hoists which also shows how difficult it was for her crew to quickly change ammunition.

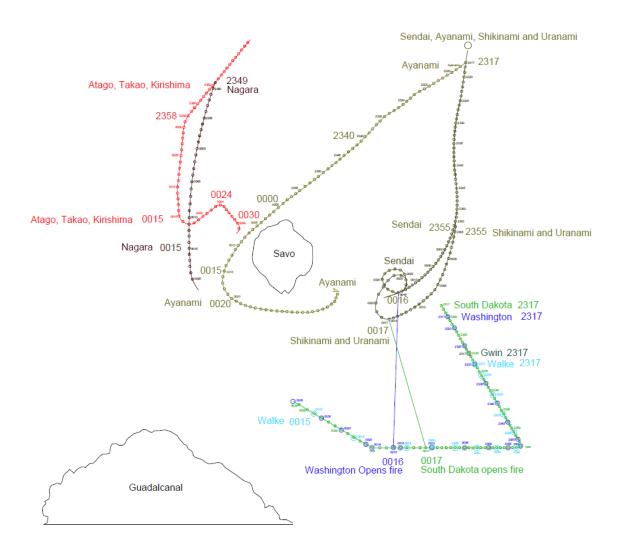
Opening Phase from 2317 to 0020 Figure 1

In the track charts *Atago, Takao*, and *Kirishima* are in red, *Nagara* is brown, *Sendai* and the *Ayanami* are in yellow, *South Dakota* is green, *Washington* is dark blue, *Walke* is light blue, other U.S. destroyers are represented by turquoise.

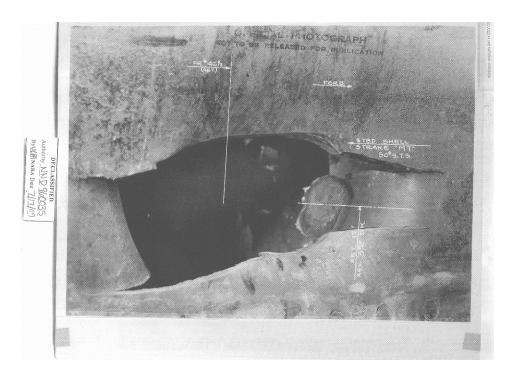
This photo is of hit 4 which is the only hit I wish to correct in Nathan Okun's and my original article on *South Dakota*'s battle damage. In the original article we said the cap head was carbonized on the main belt leaving a black circle. This idea is part of the original BuShips report, but it implies the cap head was present and this shell had an underwater trajectory and came from aft, so the firing ship had passed *South Dakota* when it was scored. I would like to correct this assessment. The cap head is gone, and the blunt flat nose punched through the exterior plate.<sup>67</sup>

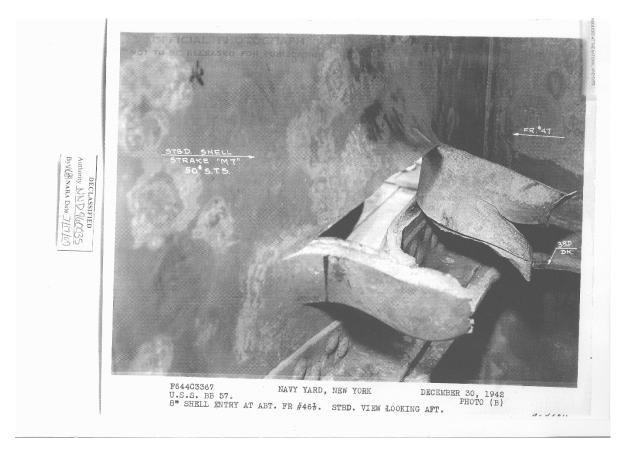
This is an internal photo of this impact and had the cap head been present the plates would have been dented but you can see the circle on the back side is still flat. This indicates the cap head was gone due to the impact with the water just like the shell was designed to do. <sup>68</sup>

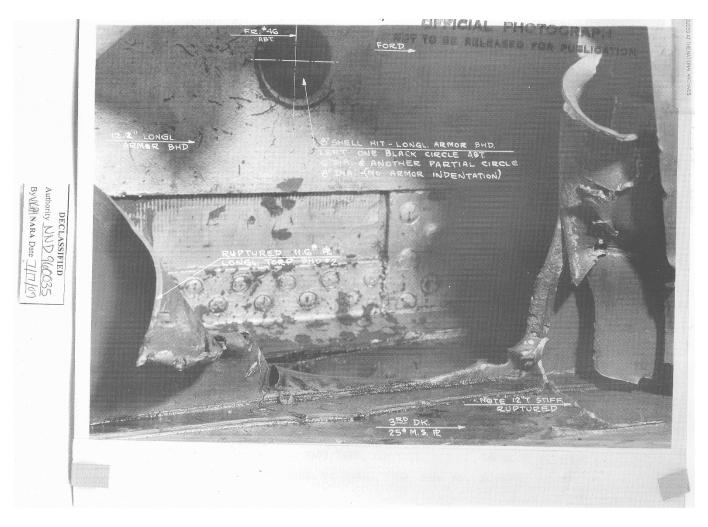
This is the view of the main belt and the black circle. I simply feel the flat nose carbonized on the main belt when it detonated. I do believe this hit came from the *Atago* and was scored at 0106.<sup>69</sup>

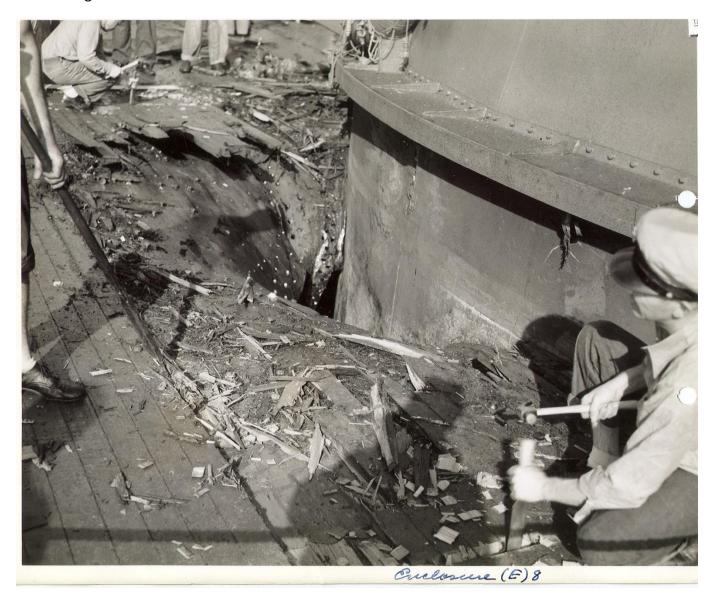
#### USS South Dakota Turret III after AP hit by Kirishima

<sup>&</sup>lt;sup>74</sup> Hit 26 was a 14-inch AP shell. There are two scars on barbette showing where the shell nose impacted below main deck level and the shell base slapped near the top and this sideways impact detonated the TNA filler, sending shrapnel into bulkhead 129 below the main deck. Circular cracks in barbette show armor was impacted with tremendous force that only an AP shell could have made. Additional damage from *Kirishima*'s main battery from Hit 21 in BuShips report caused large dent due to a near miss by 14-inch AP sending cap head and windscreen into side. AP shell traveled forward detonating below the waterline and opened seams forward 12 feet below waterline. For more information on the damage suffered by *South Dakota* during the Guadalcanal battle, please see *South Dakota* Damage Analysis.

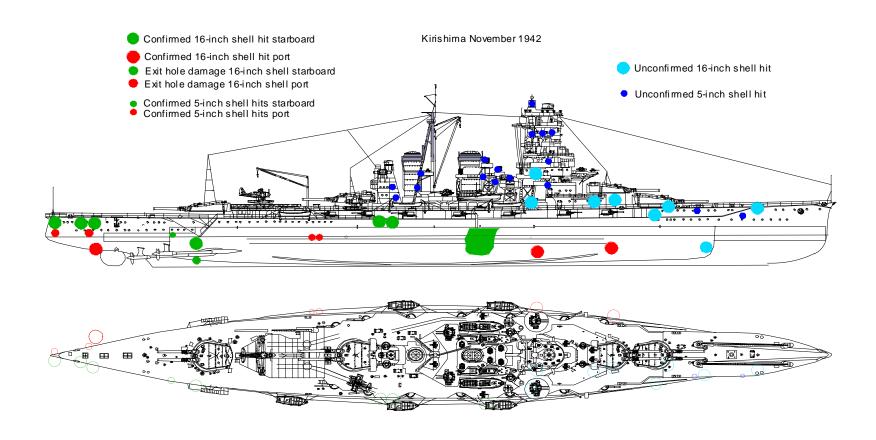
Kirishima's hit locations based on 2019 survey of wreck by Paul Allen Group

According to Lt. Ikeda and the chief damage control officer Lt. Cdr. Hayashi told him that *Kirishima* had received fourteen major caliber hits above the waterline and 17 medium caliber hits as well as six underwater hits all rated as major caliber. According to Ikeda, *Kirishima* fired 68 Type 3 [incendiary], 22 Type 0 [HE], and 27 Type 1 [AP] 14-inch shells at the enemy battleship. Lookouts reported ten 14-inch shell hits on *South Dakota*. The Damage Control Officer Hayashi prepared a hit scheme in which Lt. Ikeda meticulously copied. The hit scheme below is based on the 2019 wreck survey and where Lt. Ikeda placed hits that the wreck cannot confirm due to its condition.
