By Robert Lundgren with Anthony Tully Edited by Tony DiGiulian

On November 13, 1942, the Japanese battleship *Kirishima* was sunk in the first US-Japan battleship duel of World War II. Her wreck laid undisturbed until discovered by Dr. Bob Ballard in 1992 as part of a joint expedition by the U.S. Navy and The National Geographic Society to locate and document the shipwrecks in Iron Bottom Sound of the ships lost during the battles for Guadalcanal. Dr. Ballard's exploration of *Kirishima*'s wreck was cut short by a near-fatal mishap which made it necessary for Dr. Ballard to make an emergency ascent. As a result, only nine minutes of video was taken of the *Kirishima*'s wreck with very little of the port side viewed and only a small portion of the aft starboard side. Charles Haberlien, a naval historian with the U.S. Naval Historical Society, was with the 1992 expedition and used the expedition's ROV to film some of the debris field in 1992, but this was very limited and incomplete. This and other data gathered during this exploration was used as part of my 2009 essay "<u>Kirishima</u> Damage <u>Analysis</u>."

A second expedition, mounted by Paul G. Allen's company <u>Vulcan Inc.<

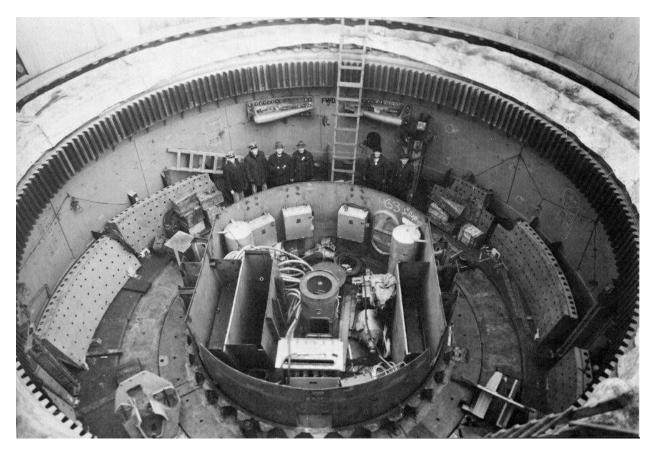
Figure 2 - The barbette structure of U.S.S. *New Jersey* (BB-62) Philadelphia Naval Shipyard photograph

Figure 2 is published in at least "Battleship *New Jersey*" by Paul Stillwell and is also at <u>http://www.NavSource.org</u>. Here is the NavSource caption for this photograph:

The New Jersey's (BB-62) No. 2 turret shell deck is seen prior to the installation of the turret rotating assembly. The turret hold-down clips are leaning against the foundation

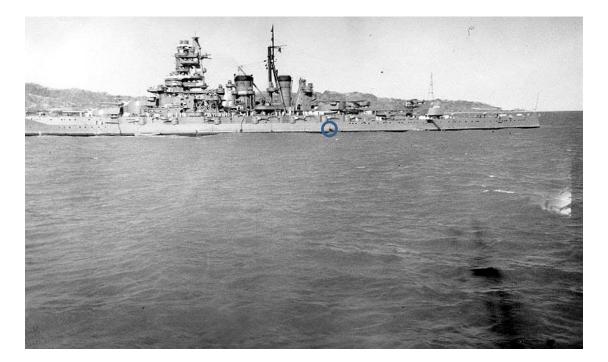
Figure 9 - *Kirishima* seen in 1937 with drainage pipe circled U.S. Naval Historical Center Photograph

In Figure 9, the unusual apparent drain hole is circled here on the port side. It helps mark the location and this drain pipe was part of her design. It is not on the starboard side.
